**APPENDIX 3.1.8-3**  
*Septic Feasibility Study*

Ref: Review of "Feasibility Study for Onsite Wastewater Treatment Systems,  
Otay Ranch Village 14 and Planning Areas 16 and 19, County of San  
Diego, California"

March 28, 2017 (Revised December 18, 2017)  
P/W 1312-02  
Report No. 1312-02-B-8R

Pursuant to your request, Advanced Geotechnical Solutions, Inc. (AGS) has prepared this feasibility study for onsite wastewater treatment systems (OWTS) within portions of the proposed Otay Ranch Village 14 and Planning Areas 16/19, San Diego County, California. The recommendations presented in the following report are based on the results of our subsurface investigation and percolation testing conducted in the northeasterly portion of the overall site (Planning Area 16, Neighborhood R-16).

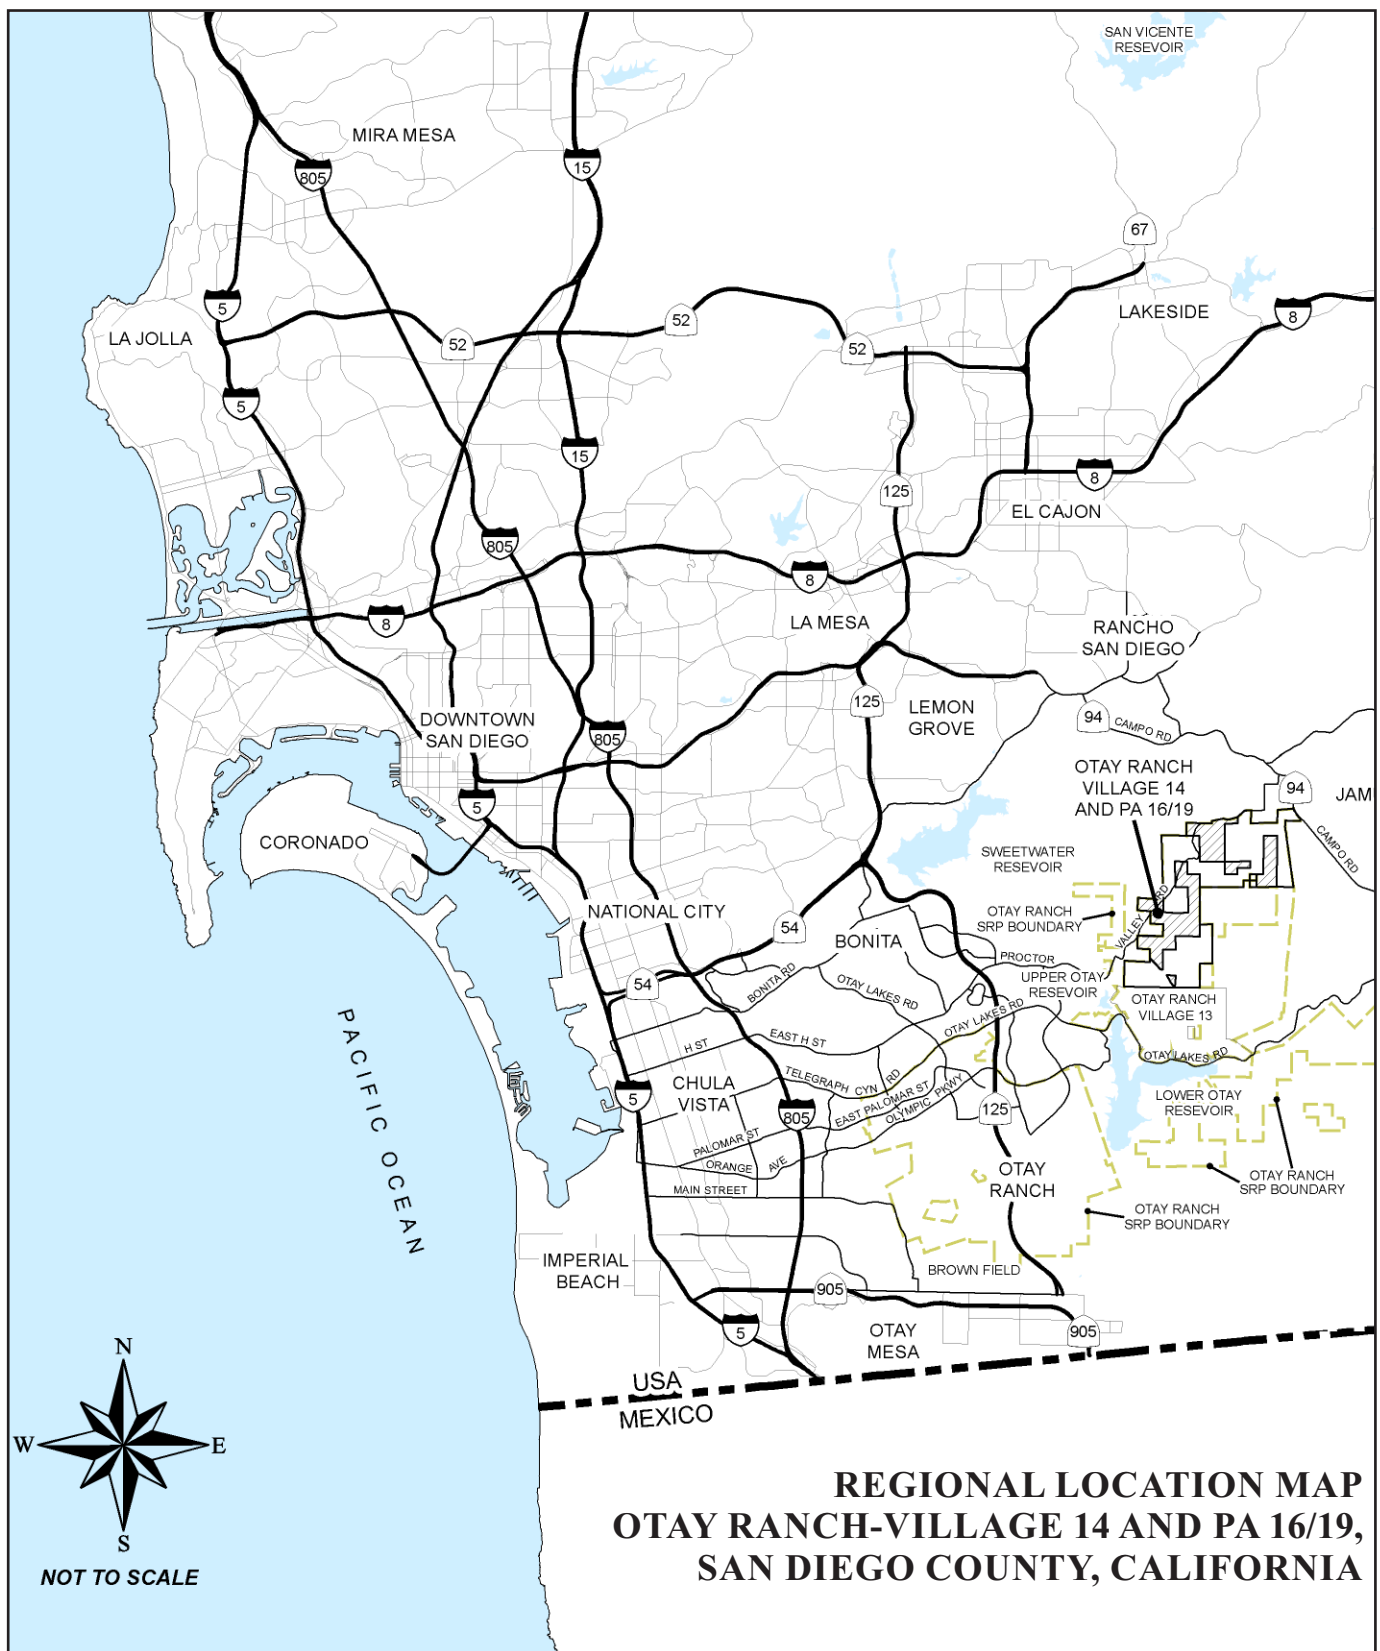
FIGURE 1

# **SITE LOCATION MAP OTAY RANCH-VILLAGE 14 AND PA 16/19, SAN DIEGO COUNTY, CALIFORNIA**

The Proposed Project is located within Township 17 South, Range 1 East, Sections 8, 16, 17, 18, 19, 20, and 30 on the USGS 7.5' Jamul Mountains quadrangle, generally along Proctor Valley Road, between the more urbanized City of Chula Vista and the rural community of Jamul, California. The project area is more specifically located within Otay Ranch Village 14 and Planning Areas 16/19 as depicted in Figure 1.
